CASE STUDIES IN ENGINEERING and ETHICAL FAILURES

Craig Wallace
CIVL 402

Kansas City Hyatt Walkway Collapse *(Beware of Field Changes)*

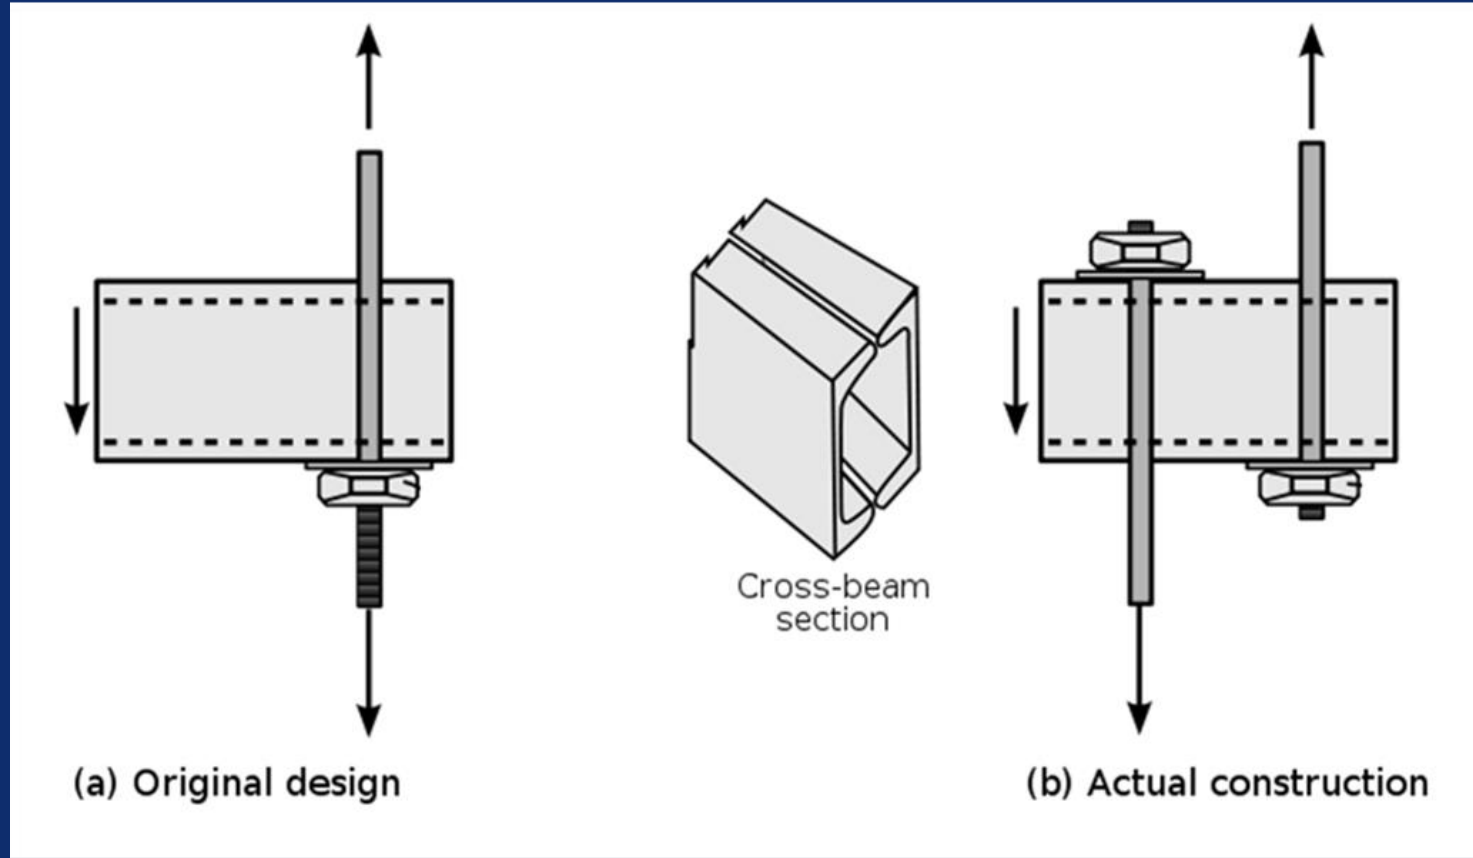
Design change suggested by contractor during construction for ease of fabrication.

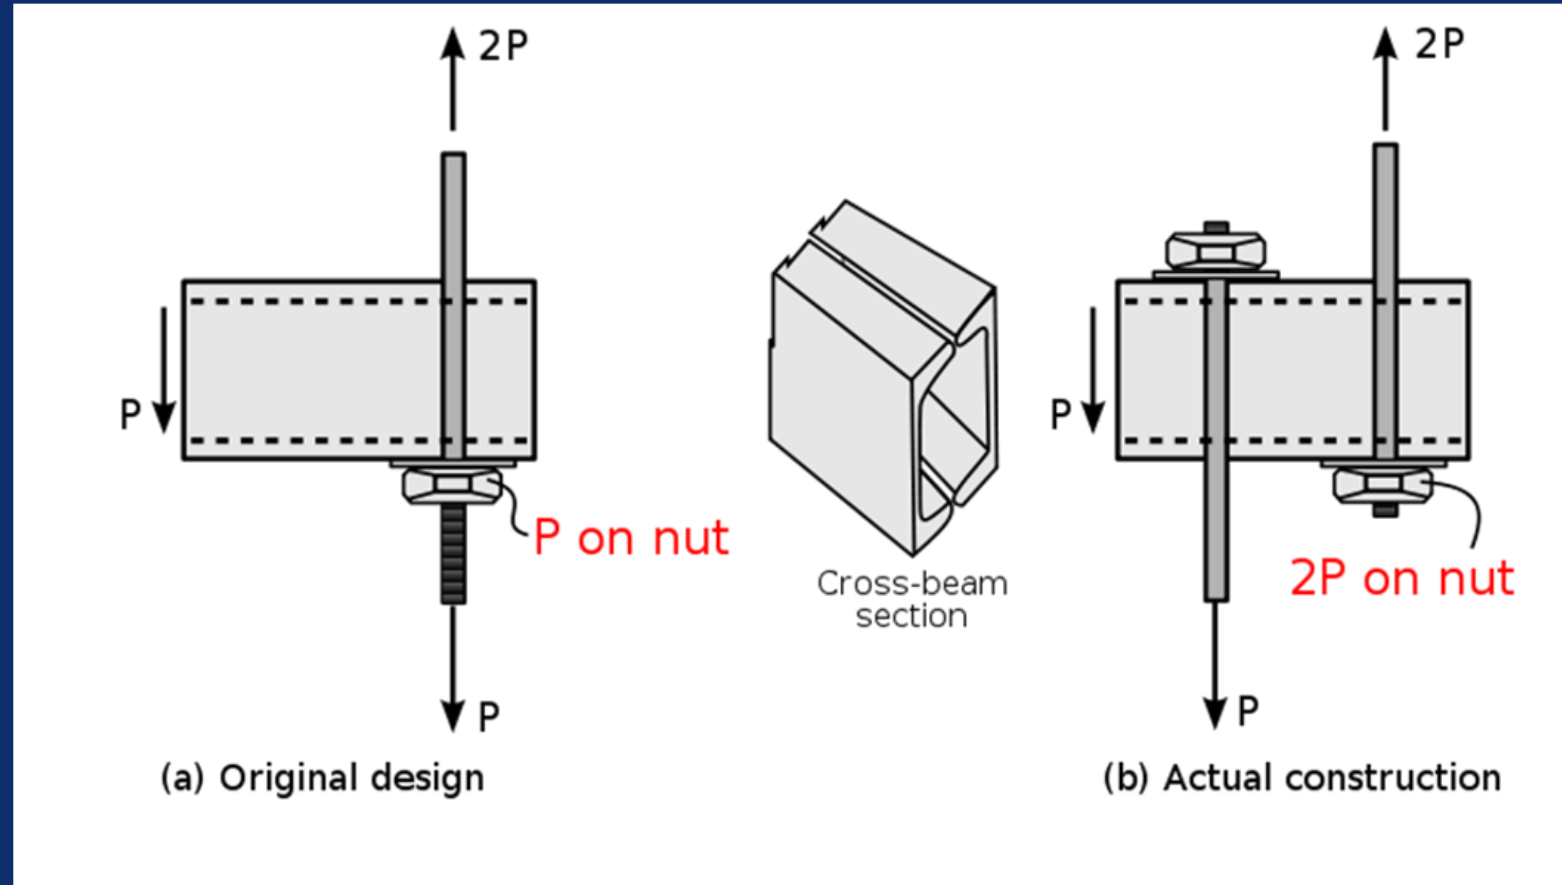
- The result was that the load on the nuts holding the fourth-floor walkway doubled, with tragic results.
- As a result of various hearings and lawsuits, several engineers lost their licenses, firms went bankrupt, and lives were ruined.

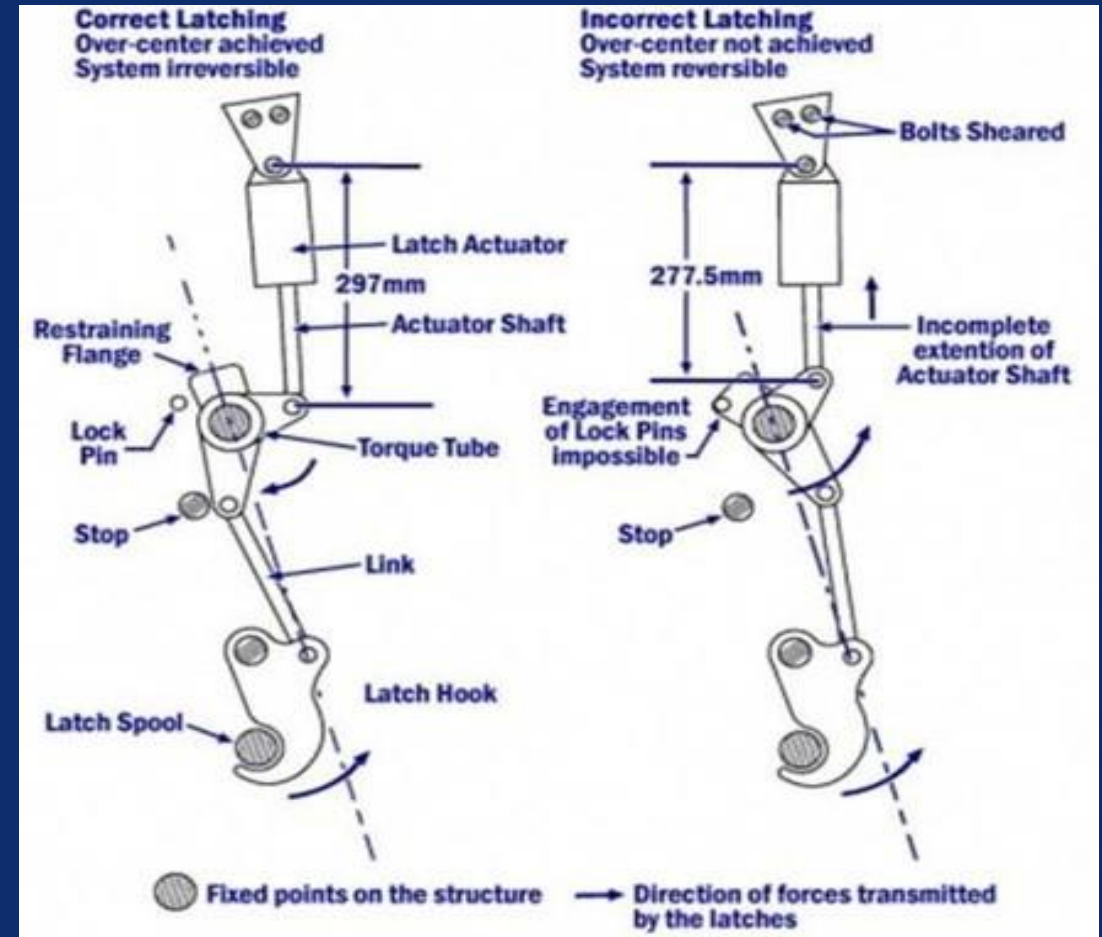
- Passenger doors are "plug type" (inward-opening) – pressure prevents door from opening.
- Cargo doors have to open outward, but pressure would assist in keeping the latches closed.
- Incomplete closure would result in pressure forcing the latches open.

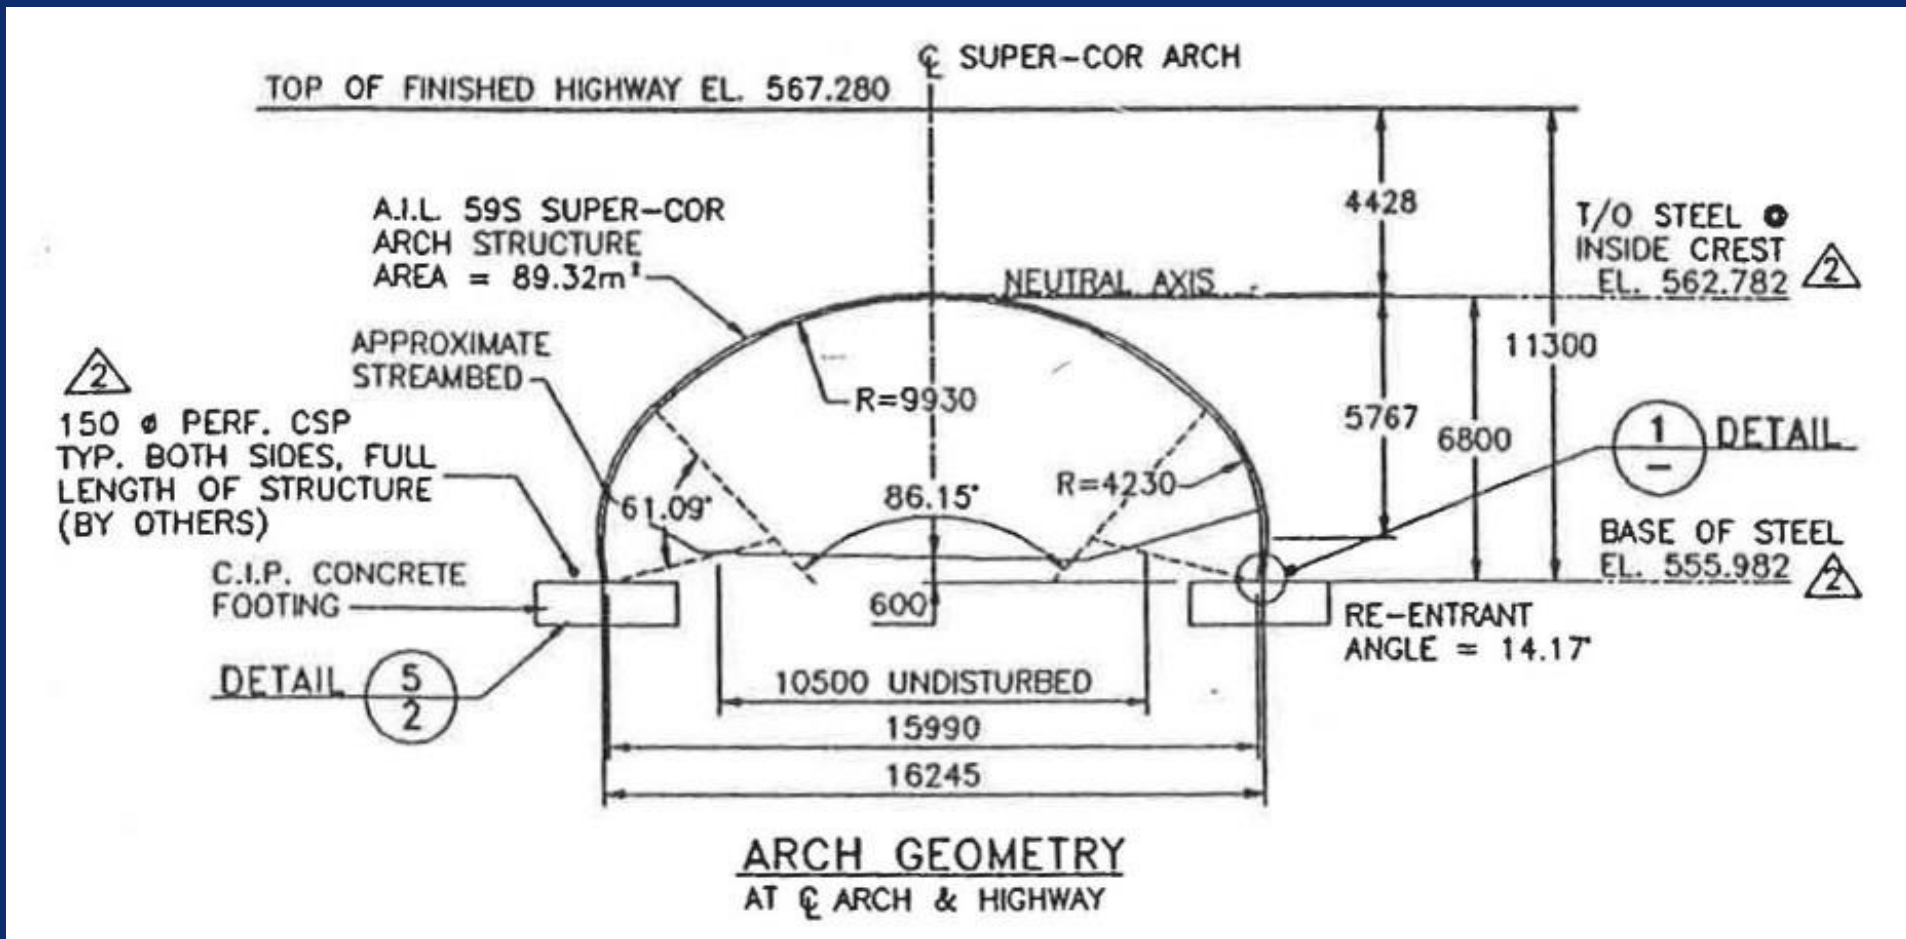
- Department of Fisheries disapproves, and requires that foundation be 1 m back from the river bank.
- Design-build contractor hires soil consultant to design pile foundations.

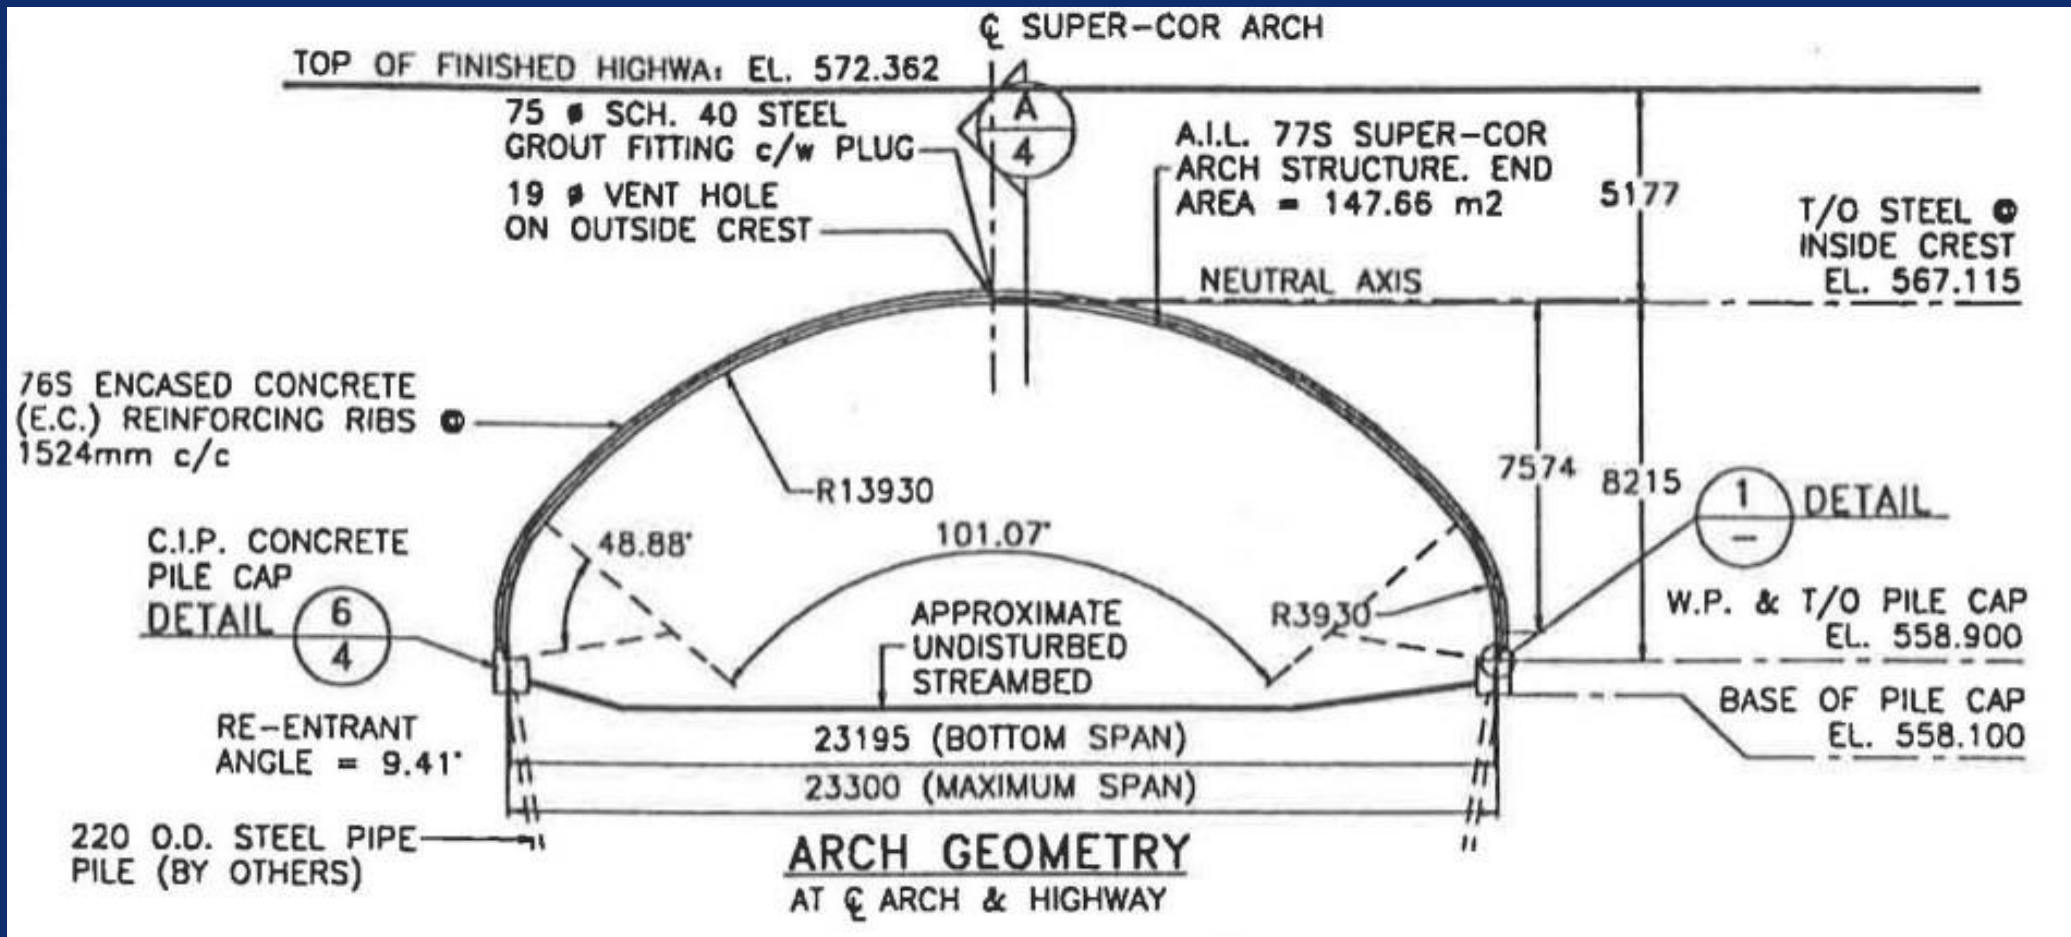
Culvert engineer's quote said that owner's or contractor's engineer must check for scour.

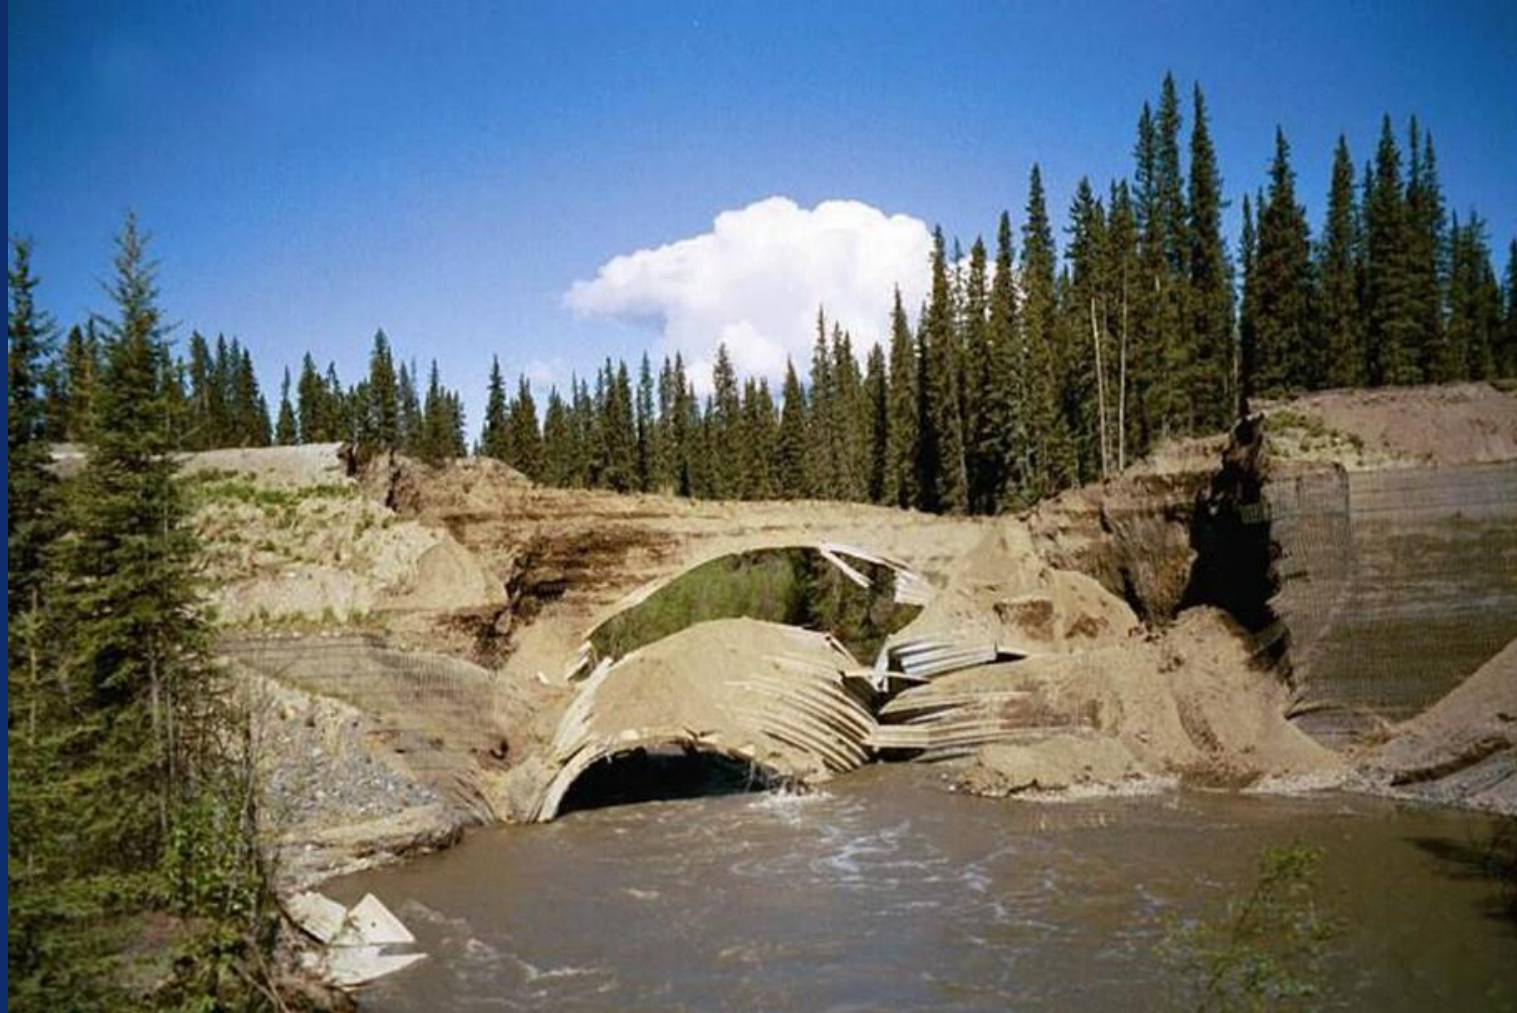
- Pile designer never saw the culvert engineer's quote.
- Pile designer had no expertise in "scour" and was only asked to design the piles.
- Design-build contractor ignored the warning on the quote and did not hire anyone to look at scour - (A hydrogeomorphologist).
- Construction proceeded without anyone examining the impact of scour.
