CASE STUDIES IN ENGINEERING and ETHICAL FAILURES

Craig Wallace
CIVL 402

Kansas City Hyatt Walkway Collapse *(Beware of Field Changes)*

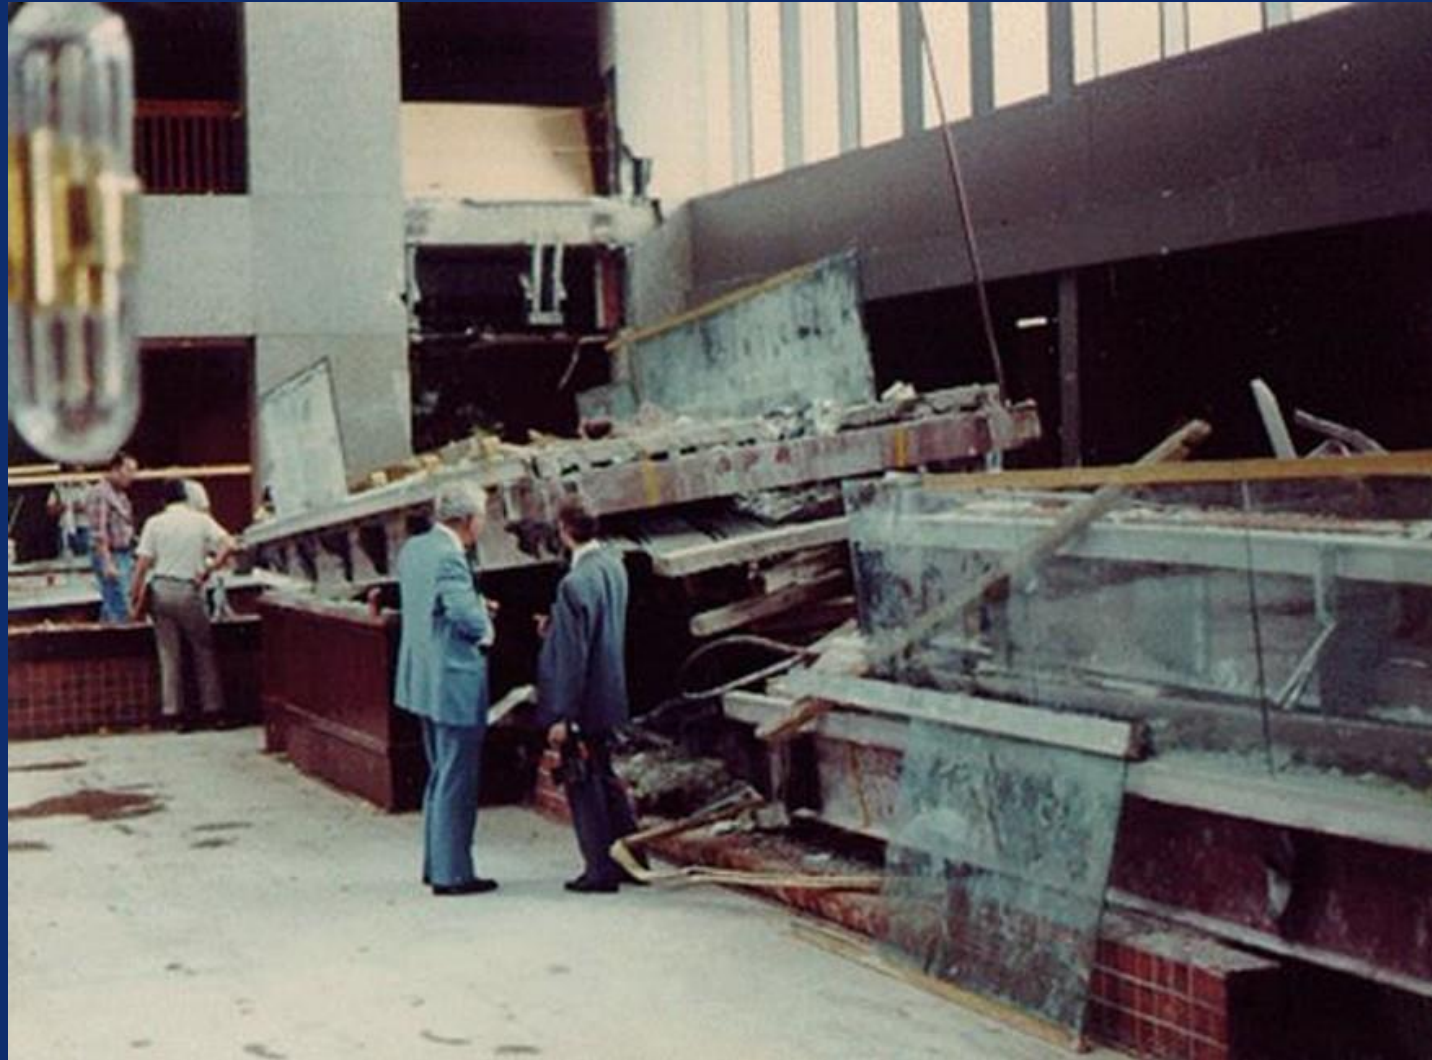
- The 40 story Hyatt Regency in Kansas City was constructed in 1978-1980.
- The atrium lobby had several suspended walkways at the second, third and fourth floor levels.
- The fourth-floor walkway was suspended directly over the second-floor walkway; the third-floor walkway was offset.
- 1600 people were in the lobby on July 17, 1981 to participate in and watch a "tea dance".
- Many stood on the walkways to watch the dance on the floor of the lobby.
- The fourth-floor walkway collapsed onto the second-floor walkway, which in turn collapsed onto the floor. 114 lives were lost.

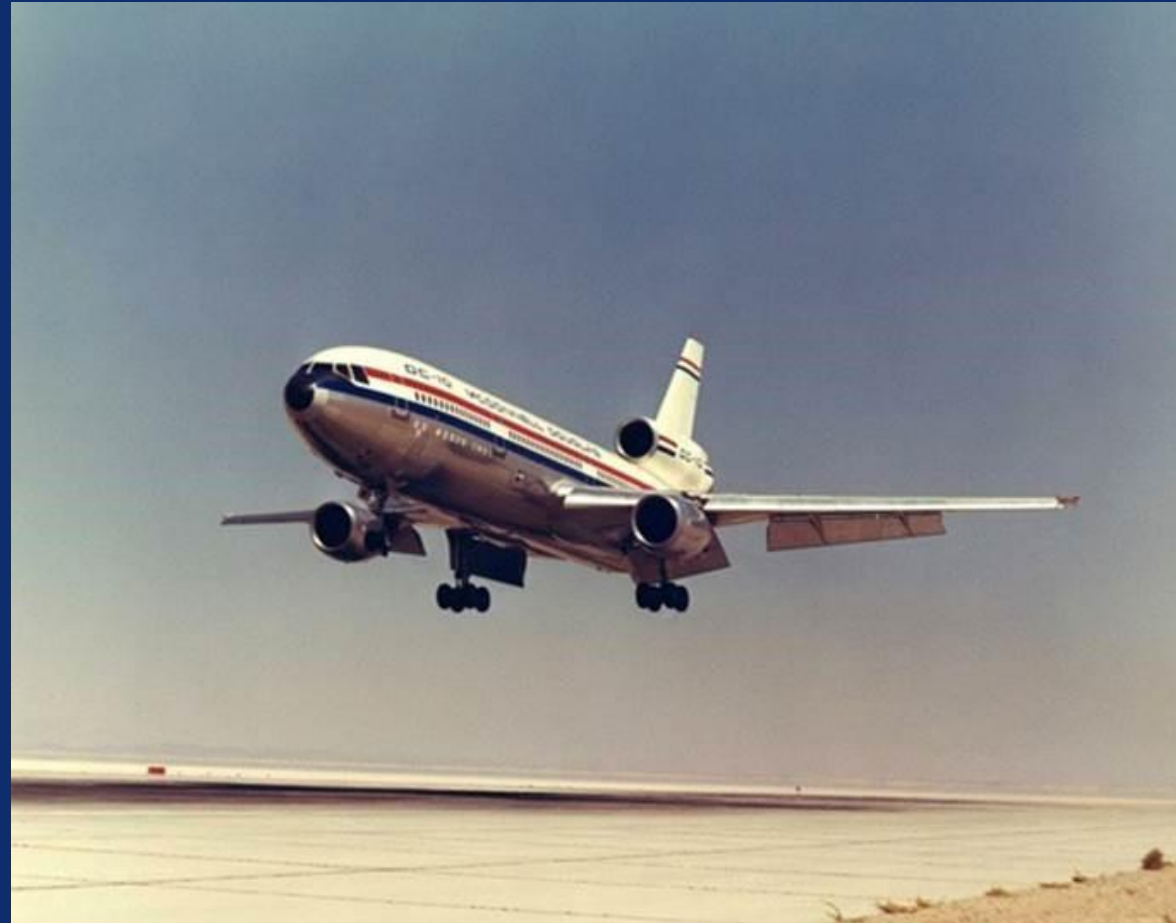
DC-10 Cargo Door

(When do you blow the whistle?)

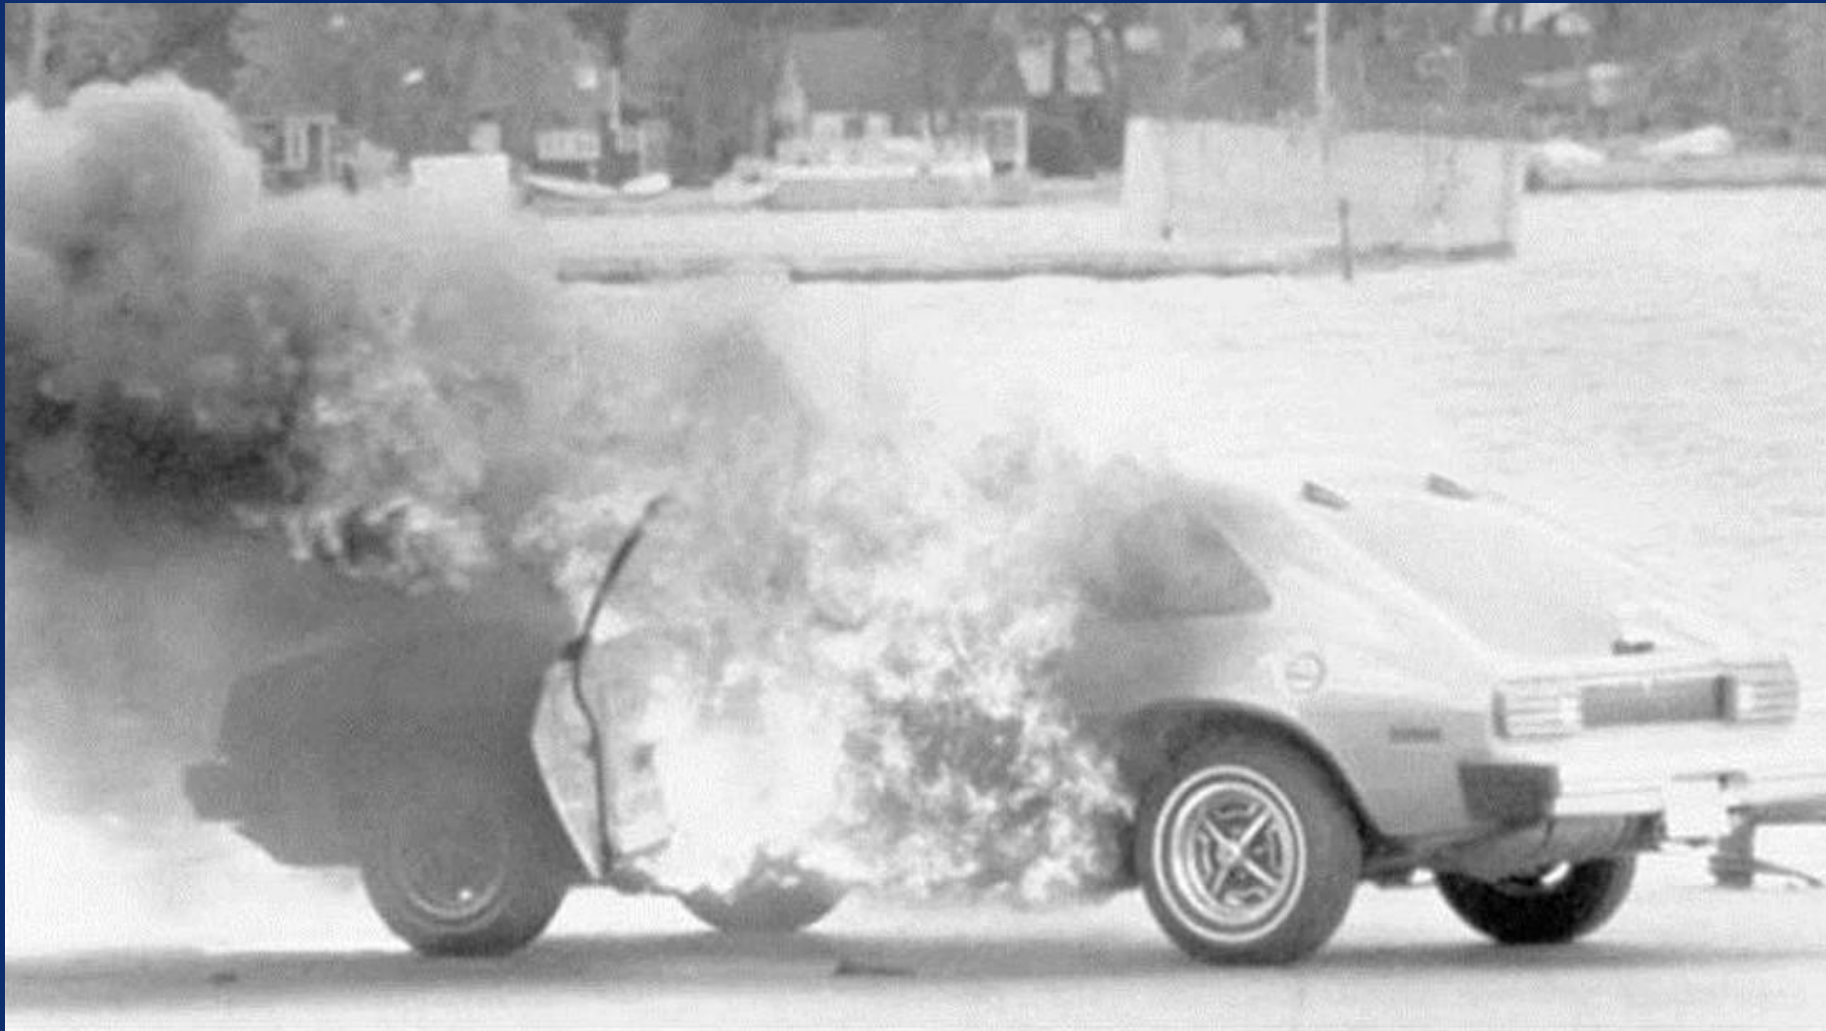
FORD PINTO

- Crash tests of prototypes showed that the Pinto would not withstand standards proposed by the National Highway Traffic Safety Administration (NHTSA) which would require cars to survive a 20 mile-per-hour impact without leaking fuel.
- A modification (a rubber bladder), estimated to cost \$11 per vehicle, would prevent the loss of fuel.
- The modification would push back the introduction of the Pinto.
- Ford decided to bring the car to market without the modification.

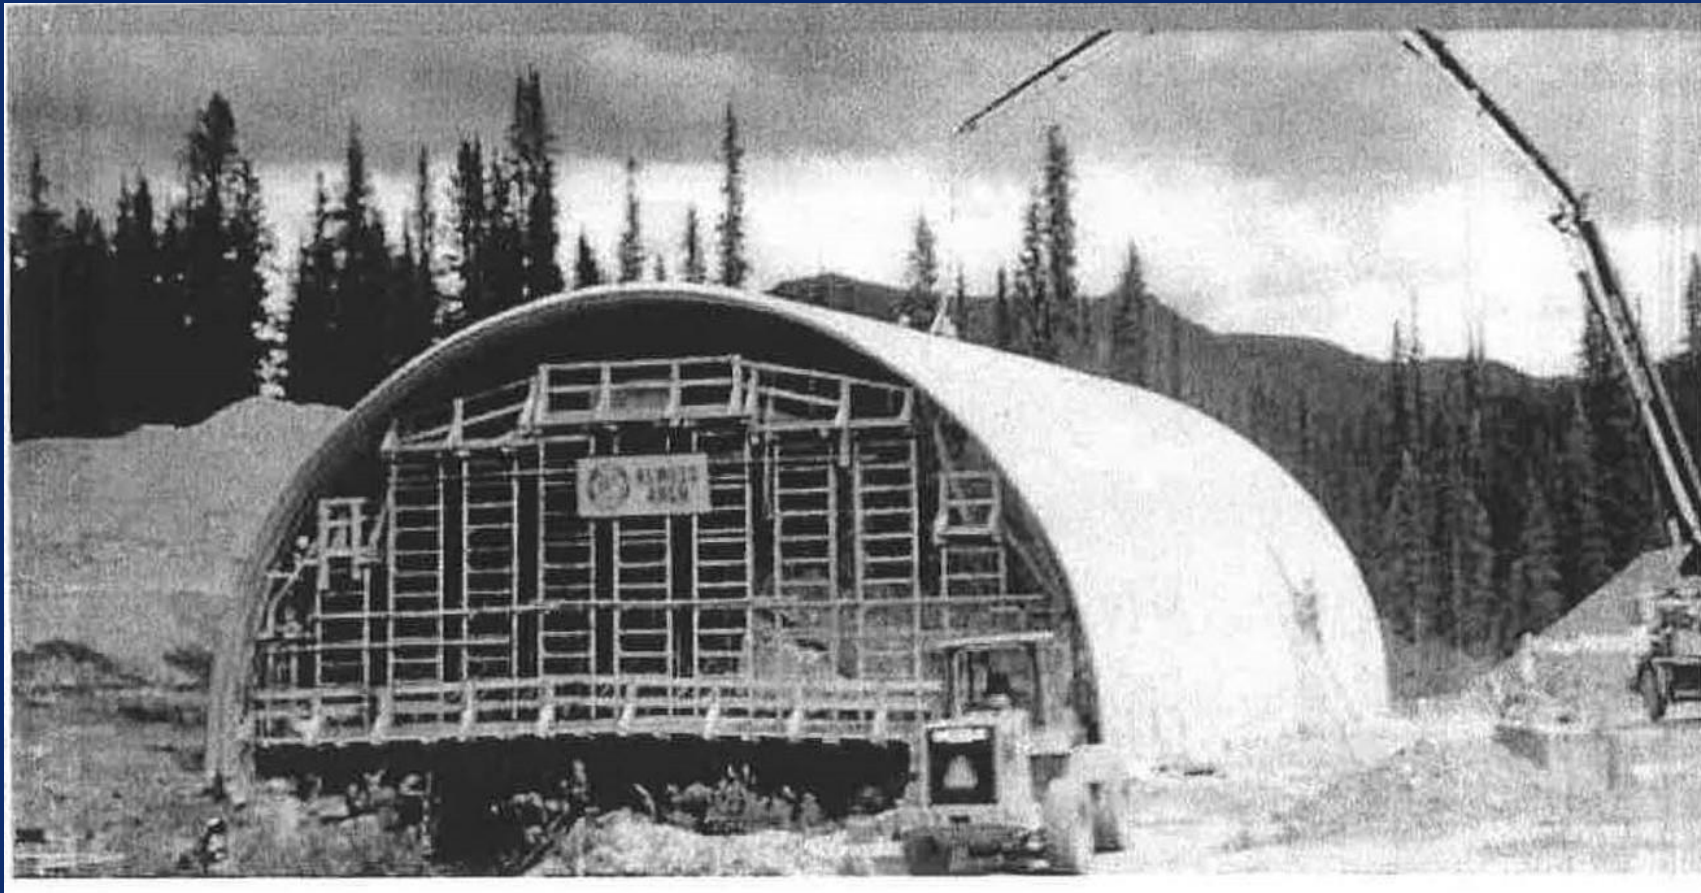
Culvert Failure

Exposure for Failure to Warn
